SIO Shipyard Representative Bi-Weekly Progress Report		
Project: AGOR 28	Contract No.: N00014-12-C-0305	Shipyard: Dakota Creek Industries
Prepared by: Paul D. Bueren Scripps Institution of Oceanography (SIO) 297 Rosecrans St. San Diego, CA 98106	Date: 30 July 2015	Program Officer: Robert (Tim) Schnoor Office of Naval Research 875 Randolph St ONR 321 Arlington, VA 22203-1995
Distribution Statement A: Approved for public release; distribution unlimited.		Report No. A002.081

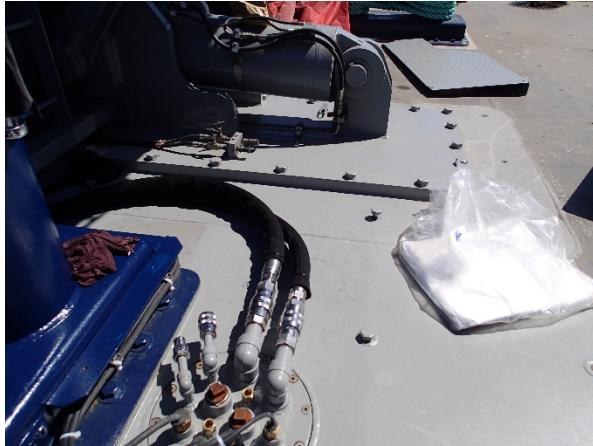
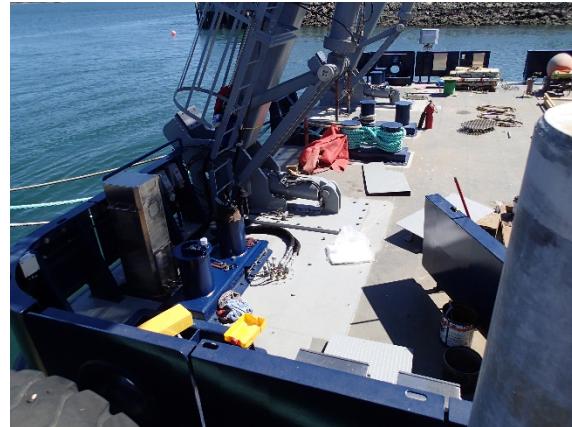
- Deck Machinery Hydraulic Piping – Flushing and pressure testing has been completed. Hydraulic hoses are being fabricated and installed. The Stern Frame hoses pictured below have anti-chaffing covers. A removable cover has been fabricated and will be installed over the hose runs to prevent tripping and damage.

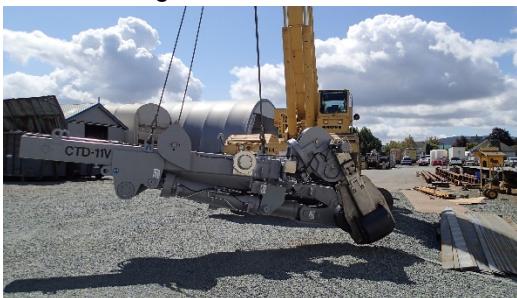
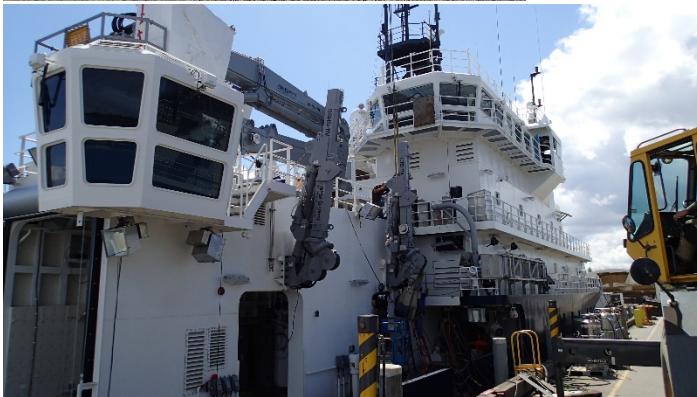
- Siemens AIS400 IO Testing - 35 of 40 pages completed. Waiting for Kongsberg and other vendors to complete the rest.
- Potable Water Tanks – Fill lines flushed and witnessed for cleanliness. Both tanks cleaned and inspected. Some paint issues were noted in both tanks. The starboard tank had an uncoated ferrous pipe collar and a small holiday. The port tank had several uncoated ferrous pipe fixtures and a holiday on the bottom. All of these were corrected and rechecked.
- Cable Runs – Resistance reading taken and recorded on several cable runs. Resistance testing is 99% complete.
- Side Handling Devices – Both devices were lifted and bolted into place.

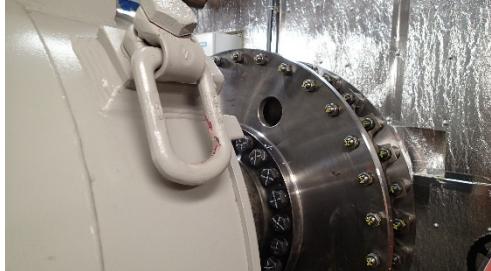
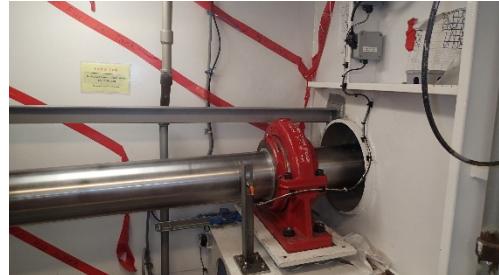
- Propulsion – Siemens was on board to begin the tuning and commissioning of Ride's propulsors.
 - Both propellers have been coupled to their motors. The motors were run up to full speed with no pitch. The shaft roller bearing caps were allowed to self-align prior to their bolts being torqued.
 - The bow thruster was briefly tested to 100%. White-Gil was in attendance.
 - The tunnel thruster was briefly tested to 50% power.

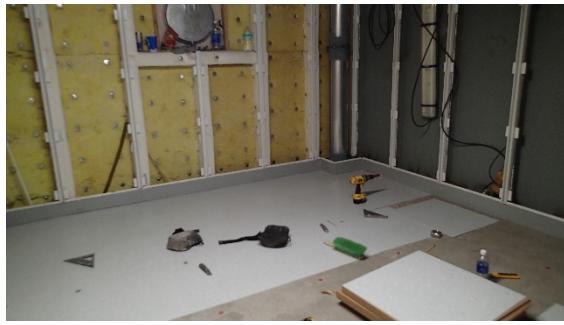
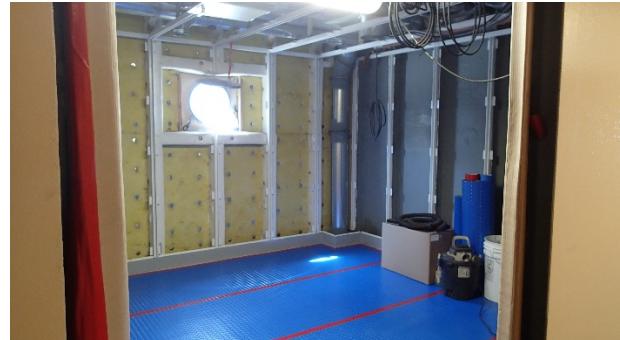
- Outfitting –
 - Dielectric Tiles laid in Computer Lab and ET Shop with protective covering applied after completion.

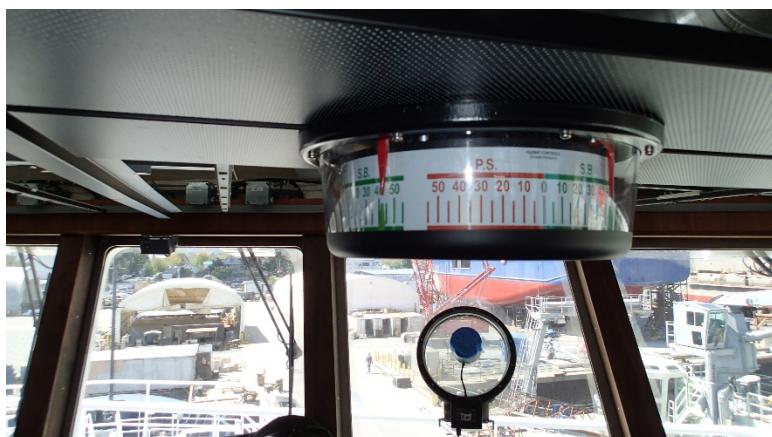
- Pilot House – Work continues on the installation of NIBS equipment, with an emphasis on the wire runs between the mast and the PH so that the false overhead can be completed.
